URGENT: MEDICAL DEVICE CORRECTION (NOTIFICATION)

This information concerns all lots for the following Impella heart pumps:

Impella® 2.5	Impella® 5.0	Impella® 5.5 with Smart Assist
Impella® LD	Impella® CP	Impella® CP with Smart Assist

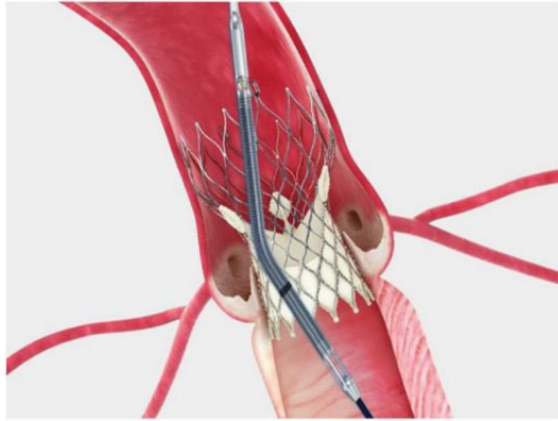
There is a potential risk for unintentional interaction of the Impella motor housing with the distal stent of a TAVR resulting in destruction of the impeller blades. This has resulted in low flow from the damaged Impella system.

The outflow struts of the TAVR can enter the outlet opening of Impella and damage the impeller (see figure below) during repositioning of the Impella while the impeller is spinning. This interaction while the impeller is spinning can result in fracture of the impeller material. Although no events have been identified, systemic embolization of the fractured impeller material is a possibility.

This risk of interaction is increased for oversized or under expanded frames with the distal ends not flush with the aortic wall, resulting in the distal stent structures oriented in such a way as to potentially enter the outflow window and allow contact of the end of the stent with the spinning impeller.

Clinicians are cautioned to position the Impella system carefully in patients with TAVR, and to be aware of this potential interaction. In this situation, clinicians should avoid repositioning while the device is spinning and should turn the device to P0 during repositioning or any movement that could bring the outlet windows into proximity to the valve stent structures.

If there is low flow observed in a patient implanted with a TAVR while on Impella heart pump support, you should consider damage of the impeller and replace the Impella pump as soon as possible.
