August 24, 2023

Marine Investigation Report MIR-23-18

Capsizing and Sinking of Crane Barge *Ambition*, Towed by *Karen Koby*

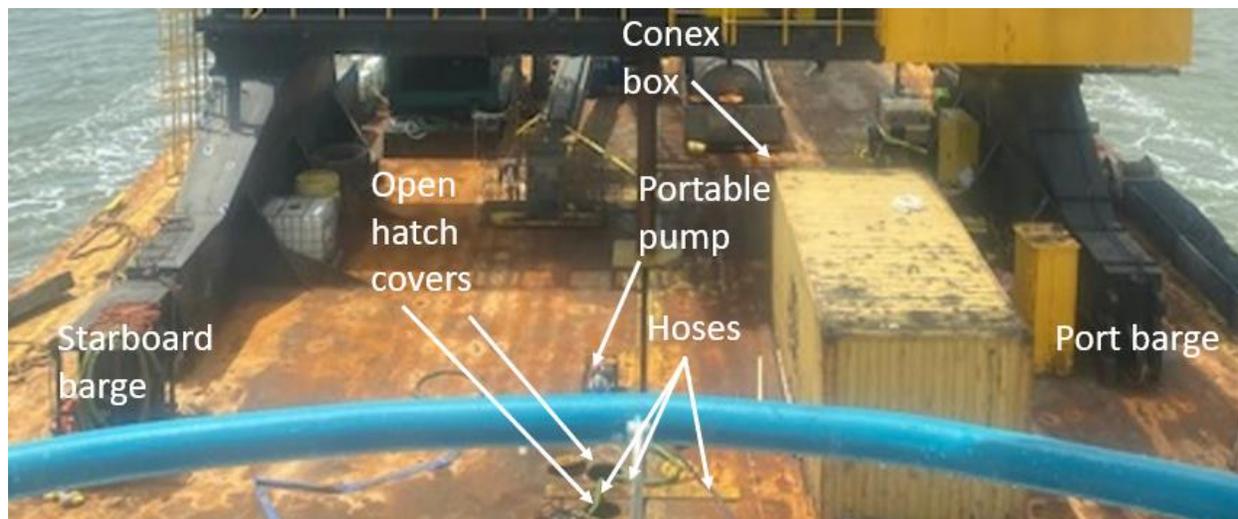
At least six hatches were not covered or secured. Two hatch covers were missing (Rigid crewmembers put a pump over one hatch and a steel plate over the other), two hatches had the covers laid over water suction hoses leading into the compartments below, and two hatch covers were not properly secured and fell off after the barge capsized. A deckhand from the *Karen Koby* told investigators that a Rigid crewmember told him that they had hoses in the compartments “all the time” in case they needed to pump water out.

Figure 5. The barge *Ambition* at 1200 on June 14 while being pushed southbound on the Calcasieu River en route to the fuel facility. A portable pump and hoses are visible leading into open hatches on the deck of the starboard barge near the bow on the inboard side, with a discharge hose leading out onto the main deck. (Source: *Karen Koby* mate)

There was evidence of past dewatering of two compartments (1P and 2P) on the starboard barge of the *Ambition*: a pump and hoses were rigged there, and a Rigid crewmember told a deckhand from the *Karen Koby* that they had the hoses in the compartments all the time in case they need to pump water out. This implies that water accumulation was a known issue with those compartments. However, none of the Rigid crewmembers were tasked with checking compartments and voids on the barge for water, even though it had been sitting idle in a fleet for 4 to 5 weeks. Thus, Rigid Constructors allowed for the *Ambition* to be taken under offshore tow without verifying the watertight integrity of the hull or any water quantities in the compartments or voids (except for the aft ones that were about half full).

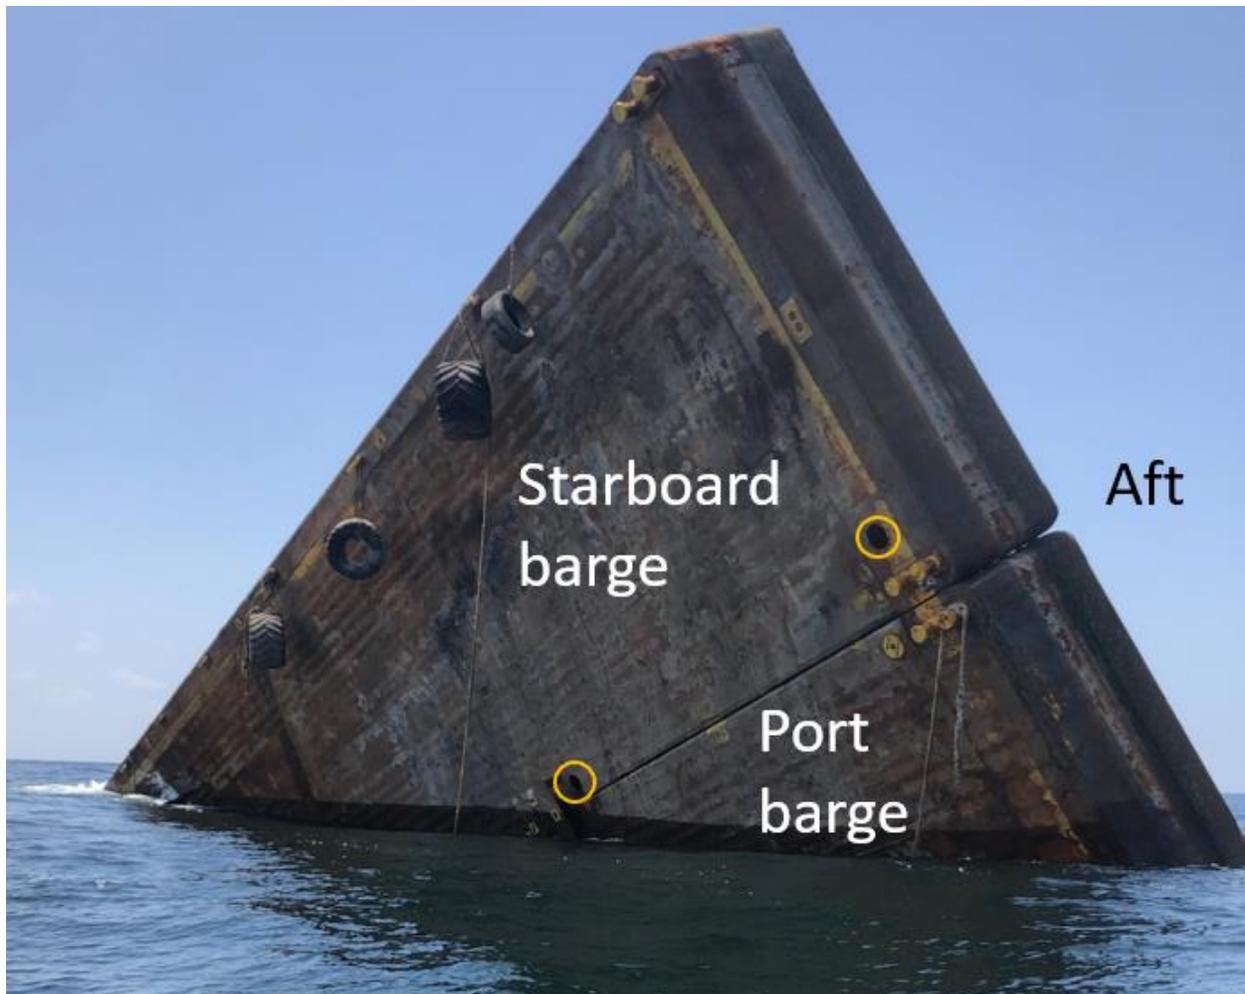
A postcasualty photo of the *Ambition* shows two missing hatch covers aft near the centerline of the starboard barge. According to the Rigid supervisor, these covers should have been secured. He told investigators that the tool used to tighten hatch covers was in the Conex box on the barge, but none of the Rigid crew were aware of the tool or its location.

Figure 6. The partially sunken barge *Ambition* the morning of the casualty with the starboard stern of the barge out of the water. The orange circles show hatch covers that had fallen off during the capsizing. (Background source: unknown)

During the tow in the Gulf of Mexico, the *Ambition* had at least six hatch covers that were either missing or not properly secured. Although a *Karen Koby* deckhand notified the captain of two missing covers, the captain did not notify the LA Carriers office (towing vessel operator) of any of the items noted in the barge inspection report. Rigid Constructor's (barge owner) crew returned to the barge but did not properly secure the missing covers (an iron sheet and a pump were used to cover the two hatches, but neither of those items made the compartments beneath watertight). As a result, the barge *Ambition* was towed offshore with open and unsecured compartments that were intended to be watertight.

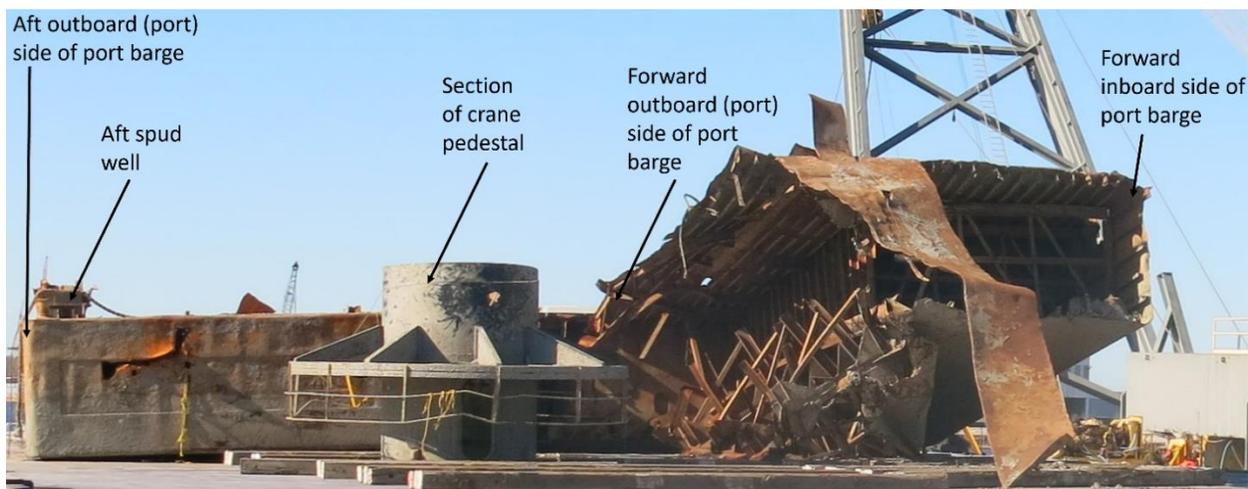
The port barge (*GD 962*) was recovered in two pieces. The area where the barge was separated was heavily damaged from salvage efforts. Investigators examined the exterior of the hull, which exhibited corrosion on all surfaces. There were numerous areas of corrosion, indentations, and deformations on all surfaces. Many sections of the hull and internal transverse frames and longitudinals exhibited poor material conditions such as severe steel corrosion. Investigators were unable to find any damage on the forward port side of the port barge from the reported contact with the channel marker since that section was destroyed.

Figure 7. The two sections of barge *GD 962* (the *Ambition's* port barge) after recovery from the Gulf of Mexico.

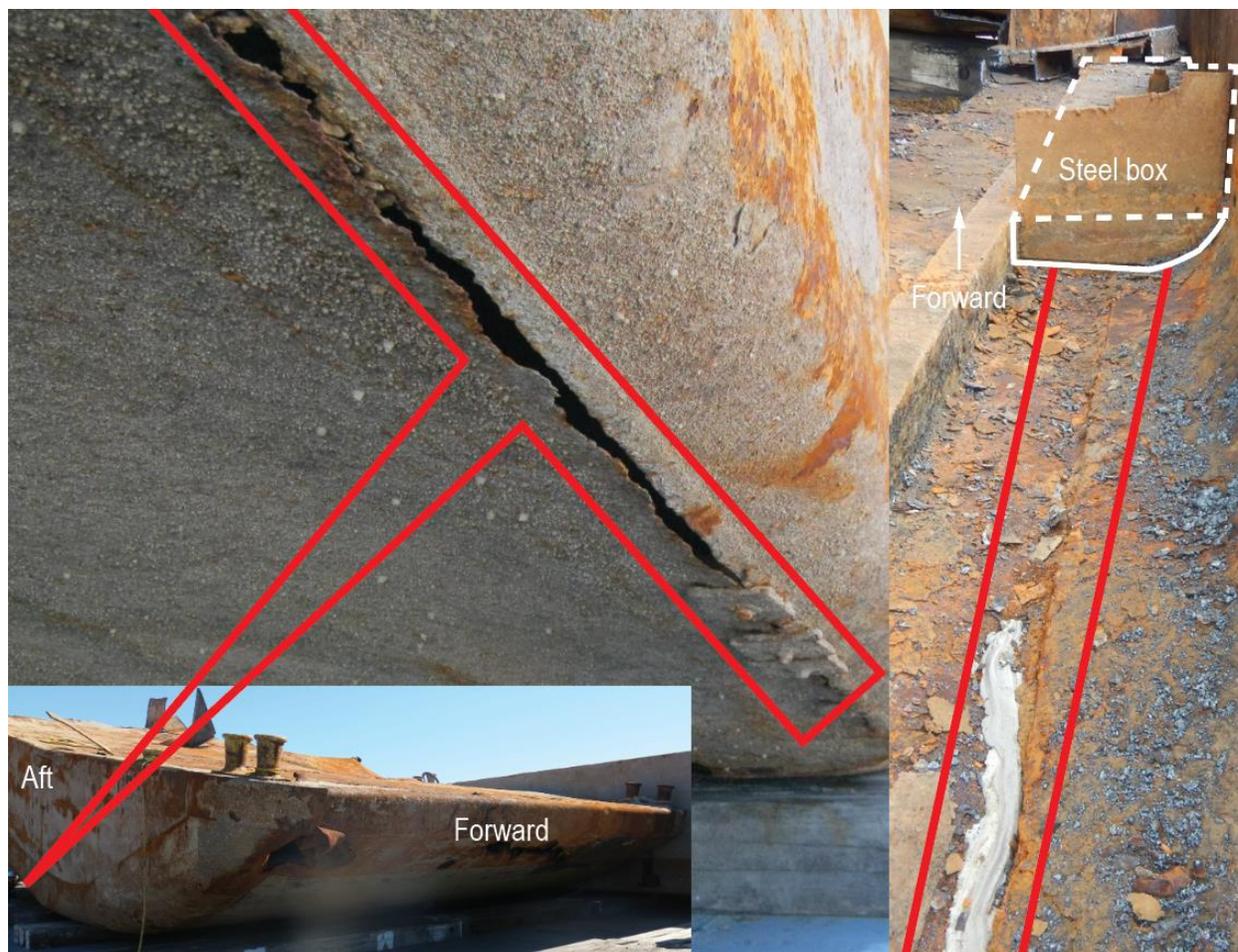
Investigators found a separation at the weld seam between the bottom plate and the bilge knuckle plate. The separation began in compartment no. 1S, where it was about 2 inches wide, with severely wasted (thin) steel on both plates. Three metal plates about 5 inches wide had been placed at the seam between the bottom plate and bilge knuckle plate; each of the three plates had a strongback-type bolt (a bar used with a soft patch to secure it when making temporary repairs) that passed into the hull at the center of each plate. Aft of the three plates, the separation between the bottom plate and bilge knuckle plate extended for about another 25 feet.

Figure 8. Left: The port barge's separation, at the weld seam, between the bottom plate and bilge knuckle plate, along with the metal plate repairs to the starboard bilge knuckle of the port barge (*GD 962*). Inset shows the location of the separation. Right: Aft (cutaway) section of the hull looking forward, showing the plate separation from the inside (between the red lines). The metal plate repairs to the separation are inside the steel box. (Sources: Coast Guard [left], K. Smith Marine Surveying [right])

This section of the hull was later cut away by parties representing Rigid Constructors and LA Carriers to examine compartment no. 1S. (Rigid Constructors retained this section of hull and a section of the transverse rake bulkhead forward of it, which exhibited severe corrosion with considerable metal loss and corrosion holes near the bottom.) The cutaway section revealed a steel box, about 13 feet long, created by welding plates, at the bottom and bilge knuckle plating at the forward portion of the separation between the bottom plate and bilge knuckle plate, encasing the endplates of the three strongback bolts that passed through the hull.

Postcasualty examination of the port barge found a 25-foot-long separation along the weld seam between the bottom plate and bilge knuckle plate with both plates exhibiting severely wasted steel, which was not consistent with other damage related to the salvage and recovery. At some point, a temporary repair, which consisted of steel

plates welded to the floor and knuckle plating, forming a box inside compartment no. 1S, had been made to the area around the separation, to contain water ingress. Three soft patches with strongback-type bolts, typically used for temporary repairs, were found along the failed seam. However, the separation had grown aft, beyond the steel box, likely due to it being in an area known to be subject to longitudinal stress. The corrosive deterioration of the bottom and bilge knuckle plating and their separation along their weld seam would have allowed water to enter compartment no. 1S of the port barge, which was the likely origin of initial water ingress.

Rigid Constructors failed to conduct permanent repairs in an area critical to hull strength, and the separation between the bottom plating and the bilge knuckle plating progressed beyond the temporary repair. Rigid Constructors' lack of hull inspection, maintenance, and permanent repairs resulted in the poor hull condition that caused the failure of the hull.

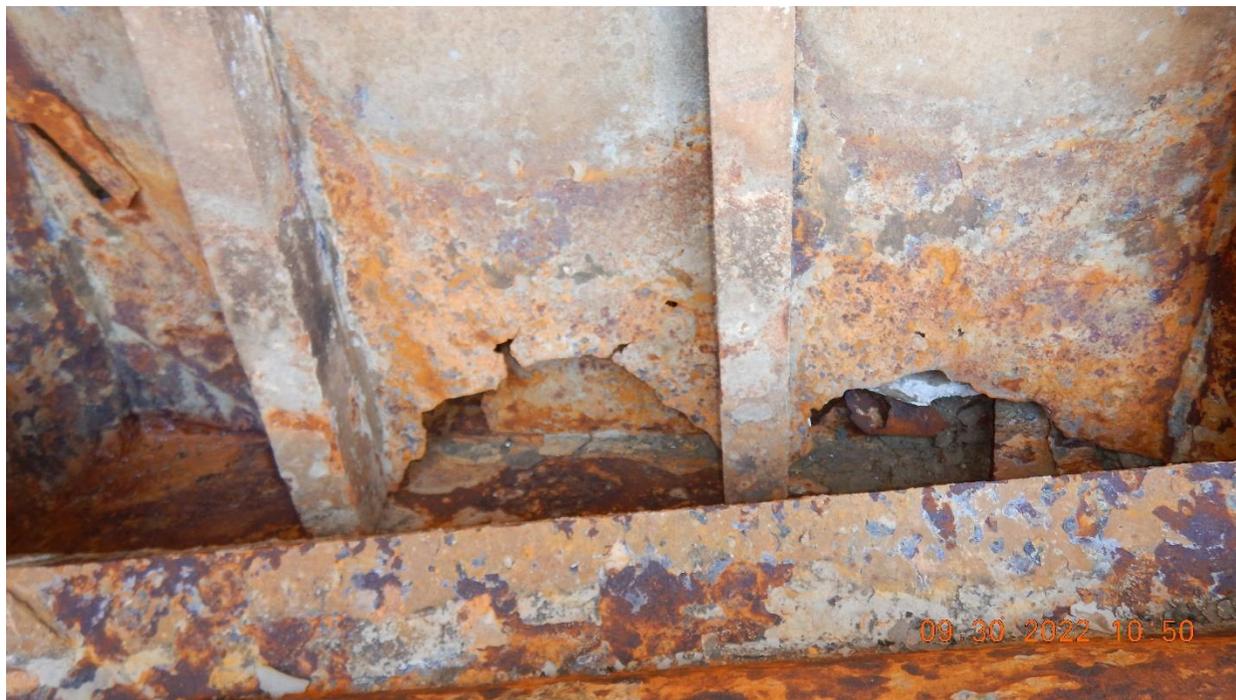
In addition to the hull damage, the bottom of the longitudinal centerline bulkhead separating the barge's nos. 1S and 1P compartments had severe corrosion. Investigators observed considerable metal loss along the bottom 2 feet of the bulkhead. Multiple

corrosion holes were found throughout the bottom section of the bulkhead. Moving up the longitudinal centerline bulkhead, toward the top of no. 1S compartment, there was surface corrosion but not at the severity observed at its bottom.

Figure 7. The bottom of the centerline longitudinal bulkhead between the no. 1S and no. 1P compartments of the port barge showing metal loss and corrosion holes. (Source: K. Smith Marine Surveying)

Investigators also found severe deterioration and steel wastage at the bottom of the centerline watertight longitudinal bulkhead (which segregated the no. 1S compartment from the no. 1P compartment of the port barge) and on the transverse bulkhead separating the rake void from the nos. 1S and 1P compartments. This allowed for the free communication of water from the compromised no. 1S compartment to the no. 1P compartment and rake void of the port barge. Based on the hull plating separation (which allowed water to enter the hull) and wastage on the interior bulkheads (which allowed water to spread across the full breadth of the port barge and to the rake void), the poor hull condition was the cause of the initial flooding.
