Deep Dive into Air Barrier Development & Implementation

La Central Building C: Air Barrier Review - 50% CD Steven Winter Associates, Inc. January 29, 2019

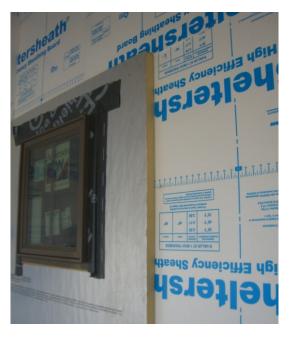
Polyisocyanurate

- R-6.5/inch
- Air and vapor impermeable if faced (other facers available)
- Can serve as air-barrier and water-resistive barrier
- Common above-deck roof insulation

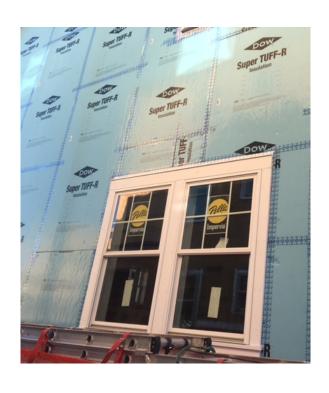
Extruded Polystyrene (XPS)

- Can be effective WRB; joints critical
- Monolithic material with no facer
- Material is very water tolerant (below grade uses)
- R-5 per inch (5.4/inch available)
- Class II VR (thickness dependent)

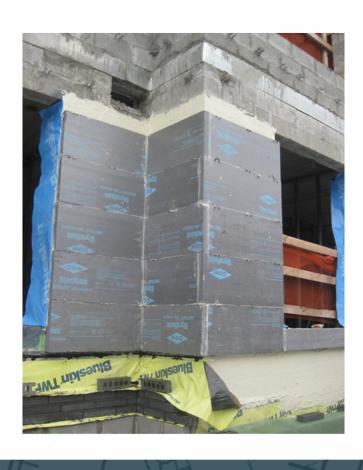
Aligned Thermal Boundary and Air Barrier

- The two boundaries work together to manage Energy, Moisture, and Increase Durability
 - Energy Control = C02 and \$\$\$ Saved
 - Moisture Control = building durability
 - Comfort Control = happy occupants
- To Function Properly Must be:
 - Continuous (no gaps)
 - Aligned with each other

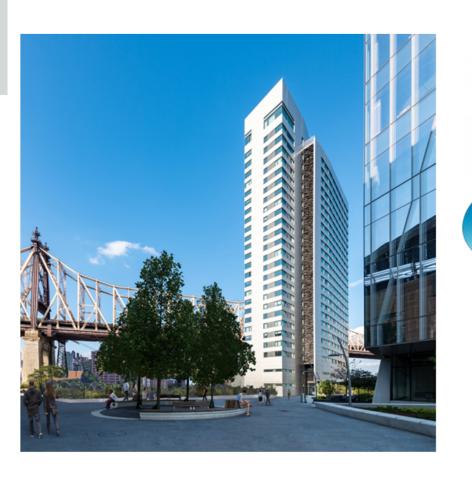
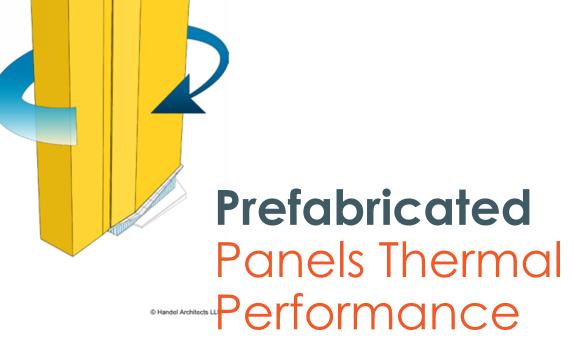
Prefab Panels Air-barrier and Sealing

BEFORE PANEL SUPPORTS SEALED

AFTER PANEL SUPPORTS SEALED

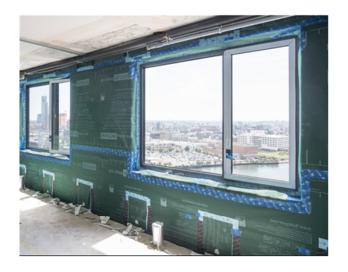
Prefab Panels Pros and Cons

- Speed of construction
- Quality control in the factory
- Can be extremely efficient and air tight

- Cost
- Coordination and design assistance needed very early on
- Logistics/shipping to site
- Ability to perform air leakage testing on site/sequencing
- Detailing at panel edges is crucial

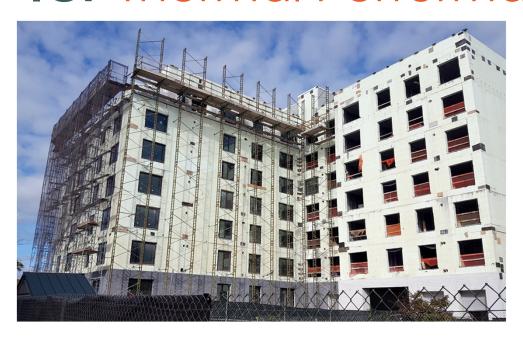
ICF Thermal Performance

2- 5/8" EPS each side + thermal mass of concrete for effective R-24.1 Additional insert at 2" increments up to R-48

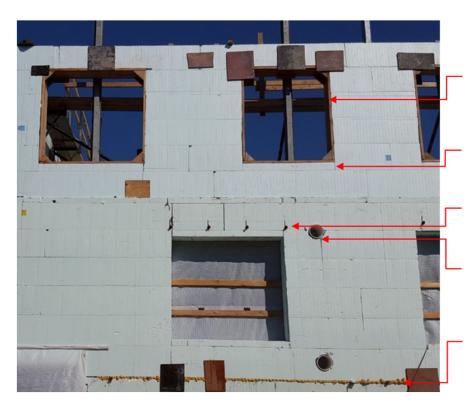
ICF Air Barrier and Sealing

Integral cast insulated jamb are cleanest tightest detail

Avoid Panel Joint at Opening, which allow water/air infiltration

Min. Thermal bridge of Brick Angle

Coordination of Min. Penetration Sleeve

Provide reinforcement at floor edge to prevent gaps

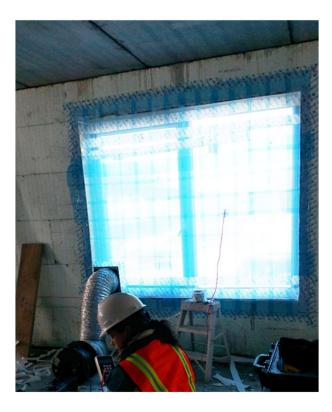
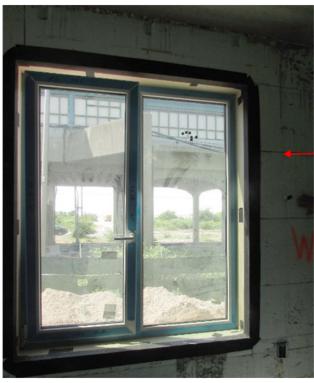
ICF Air Barrier and Sealing

Joint of ICF allow air pathway.

Gyp bd finish adds to the air tightness

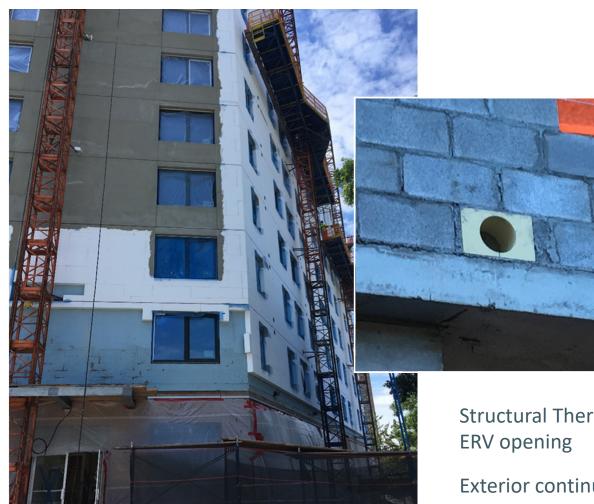
CMU Back-up Thermal Performance

Structural Thermal Break at Individual ERV opening

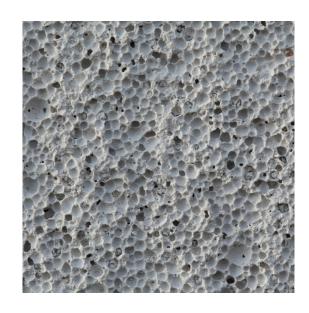
Aerated Autoclaved Concrete

R-1.2 per inch (varies) Compressive Strength up to 1200 psi

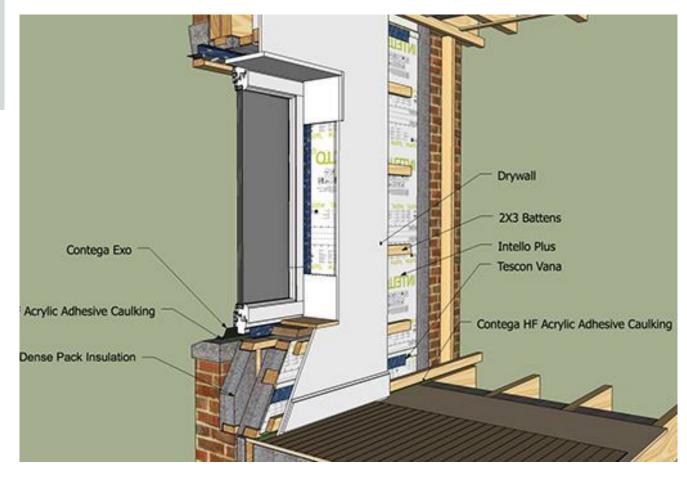
Air Barrier Retrofit Masonry Const.

HEAD/JAMB SIM. 2X4 STUD / **DENSE PACK** INSUL. INTELLO PLUS OR DB+ AIRTIGHT MEMBRANE & SMART VAPOR RETARDER 2X3 HORIZONTAL **CONTEGA EXO &** BATTENS 20"O.C./ **CONTEGA HF CAULKING** SERVICE CAVITY WITH **OPTIONAL INSULATION** WOOD BRICK MOULD TESCON PROFIL TAPE **CONTEGA EXO &** TESCON PROFIL TAPE **CONTEGA HF CAULKING** INTELLO PLUS OR DB+ AIRTIGHT MASONRY SILL -MEMBRANE & SMART VAPOR RETARDER 2X4 STUD / **DENSE PACK EXISTING MASONRY WALL/** INSUL. **REPAIR & REPOINT AS** REQUIRED TO SHED WATER AT EXTERIOR FACE & MAKE WINDTIGHT SILL

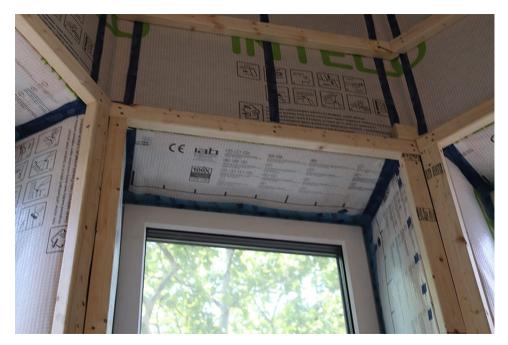
Air Barrier Retrofit Masonry Const.

Existing brick wall Existing window Existing window buck Cut and install interior rigid insulation to cover existing window buck Interior stud wall framed flush to the rigid insulation Install interior jamb extension to cover the exposed edge of the rigid insulation and stud framing Install drywall to butt up against the interior jamb extension Install window trim to cover butt joint of jamb extension to drywall

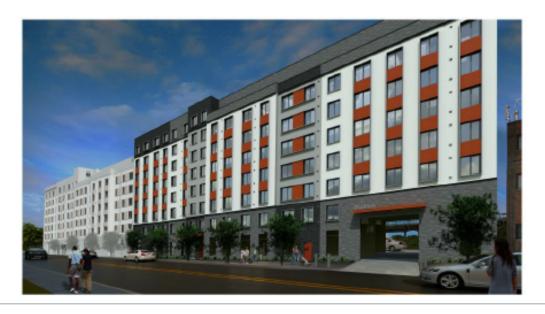
Blower Door Test Plan

WHOLE BUILDING INFILTRATION TESTING PLAN

TO DETERMINE COMPLIANCE WITH PHIUS+ AIRTIGHTNESS REQUIREMENTS AT BEACH GREEN DUNES PHASE II 45-19 ROCKAWAY BEACH BLVD., QUEENS, NY 11691 REV 1

Intentional Opening	Test Setting	Notes
Windows, doors, skylights in the building enclosure	Closed and latched	
Doors and operable windows inside the test enclosure	Open	Use stairways to connect all zones of the building
Fire dampers	Remain as found	
Dryer doors	Closed and latched	
Gas meter room	Door to gas meter room closed and weather stripped	
Waste handling system	Trash chute termination at roof taped off. Door to trash rooms closed.	
ERVs (apartments)	Fan off, any dampers closed. Ducts to the outside sealed inside the ERV cabinet in each apartment.	Ventilation is continuous, so can remain taped off
Motorized dampers: ERV-4 (cellar)	Fan off, dampers closed. Taped off from the exterior	Ventilation is continuous, so dampers closed and sealed off
Motorized dampers: ERV-5 (1st floor)	Fan off, dampers closed. Taped off from the exterior	Ventilation is continuous, so dampers closed and sealed off
Motorized dampers: ERV-2A (1st floor)	Fan off, dampers closed. Taped off from the exterior	Ventilation is continuous, so dampers closed and sealed off

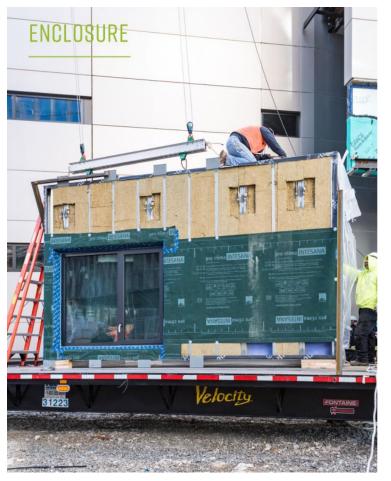
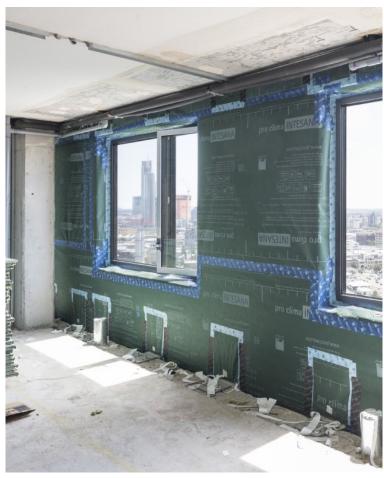
Wall Panels

- 352 units, student housing
- Roosevelt Island, NY
- Panelized wall system

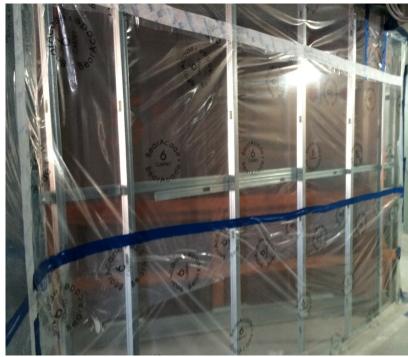
Guarded Test & Temporary Barriers

- Original plan no whole floor testing
- Revised plan guarded testing on 4th, 5th and 6th floors
- Window & Door Leakage
- Façade Leakage
- Compartmentalization

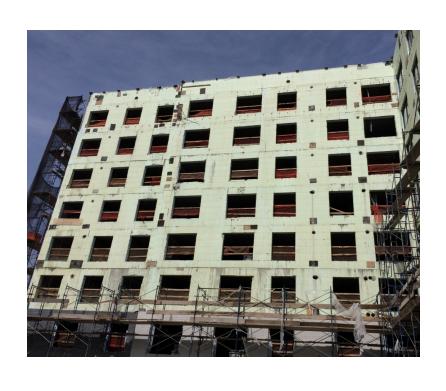
Wall Inspections

ICF doesn't require as many inspections for insulation and air barrier

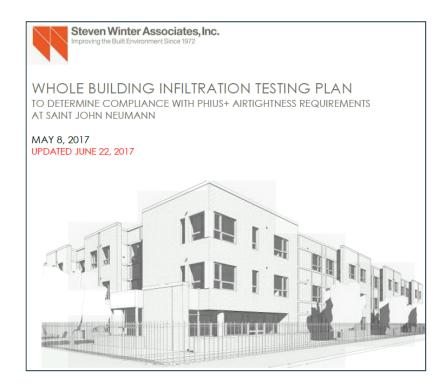
Blower Door Test Conditions

Motorized damper: Laundry Room (2 nd floor)	Fan off, dampers closed. Taped off from the exterior	Untaped for Method A test
Motorized damper: ERV-2 (2 nd floor)	Fan off, dampers closed. Taped off from the exterior	Ventilation is continuous, so dampers closed and sealed
Motorized dampers: EMR (1st floor) Stair A Star B Flevator	Taped off from the exterior	Untaped for Method A test

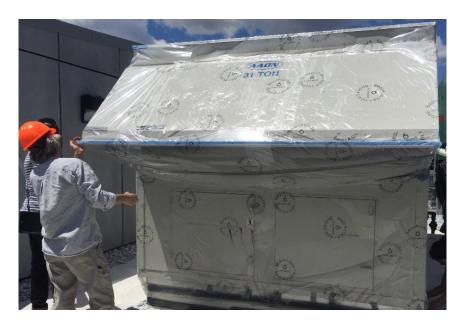
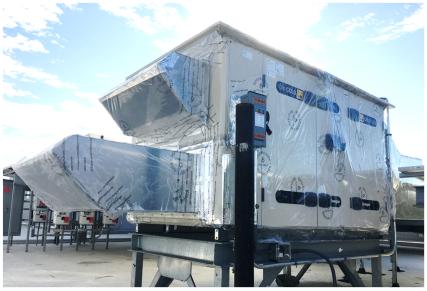
Central ERVs and Blower Door

- Need to seal off ERVs for the test
- Wrap rooftop ERVs and/or seal exterior intake and exhaust louver ports
