Construction Manager/
Subcontractor/Tradesperson Training Session 3:
QA/QC Techniques for Ensuring Success

Steven Winter Associates, Inc.
Improving the Built Environment Since 1972

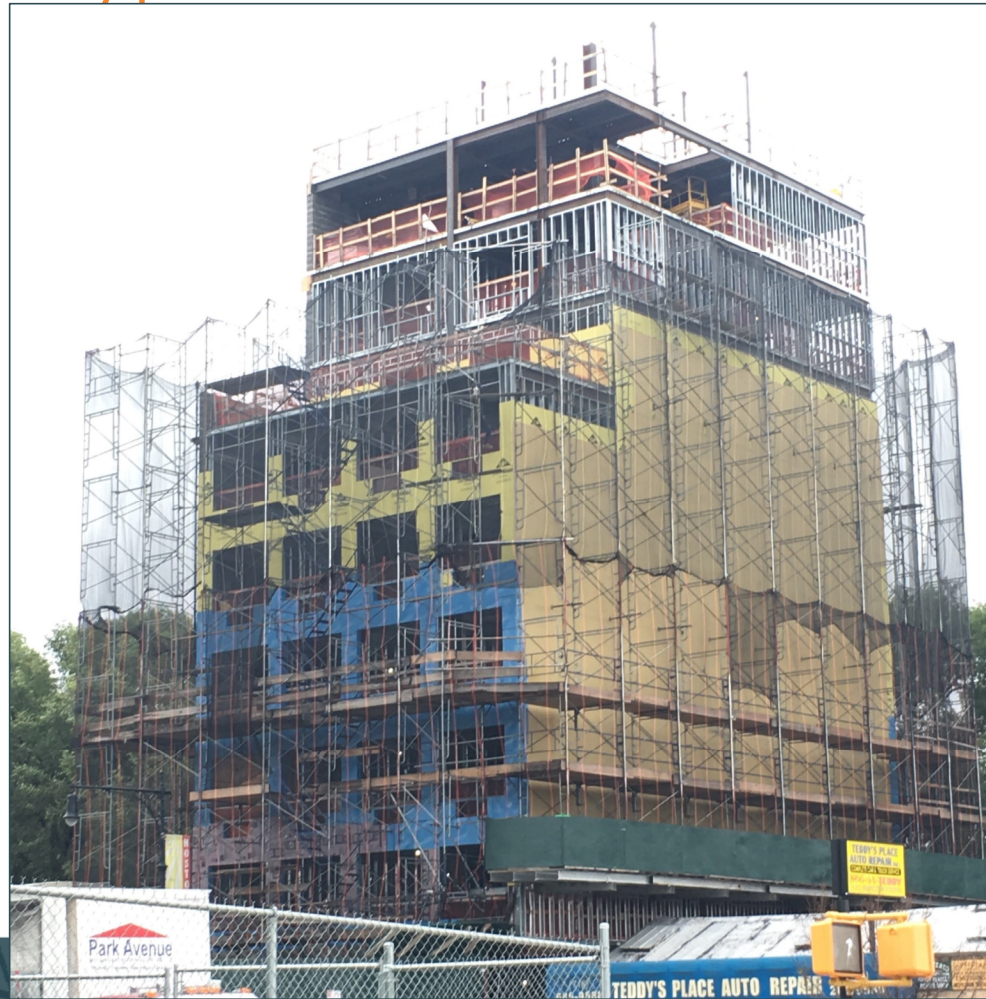
- Steel studs
- Exterior grade gypsum
- Fluid applied air barrier
- Sheet applied air barrier
- Exterior insulation
- Assumed finish of brick and EIFS
- PTACs

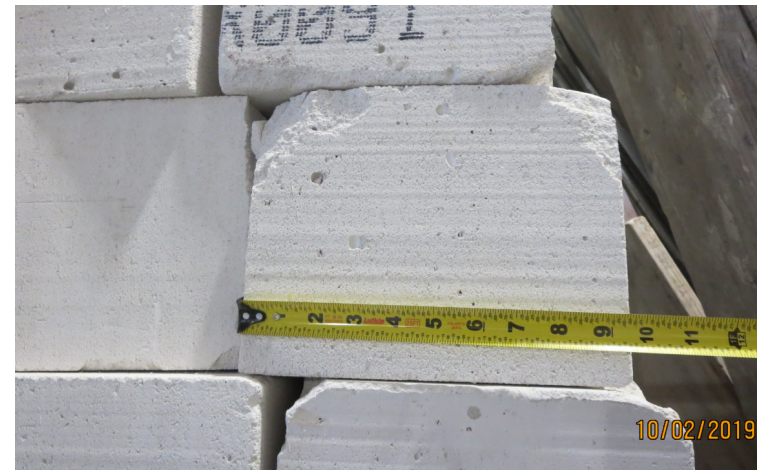
- Autoclaved aerated concrete (AAC): a lightweight, precast, foam concrete building material suitable for producing concrete masonry unit (CMU) like blocks.
 - Composition: quartz sand, calcined gypsum, lime, cement, water and aluminum powder, cured under heat and pressure

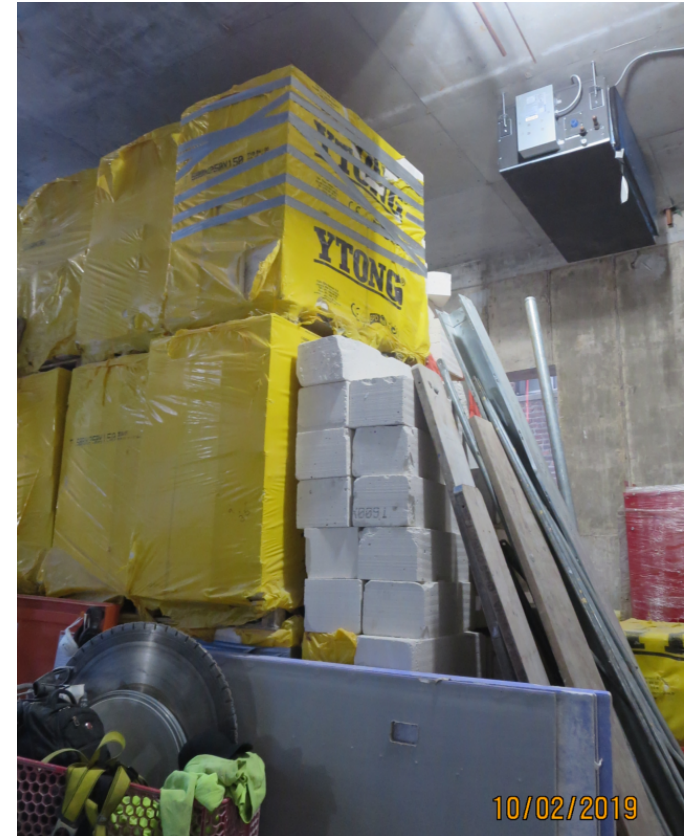
- **AAC Benefits** (to name a few)
 - Workable with hand tools, lightweight, fireproof, thermal insulation, less portland cement, noise reduction, moisture regulation

AAC + PH = ✓
- **AAC Blocks** – Made by YTONG, Aercon Florida, etc

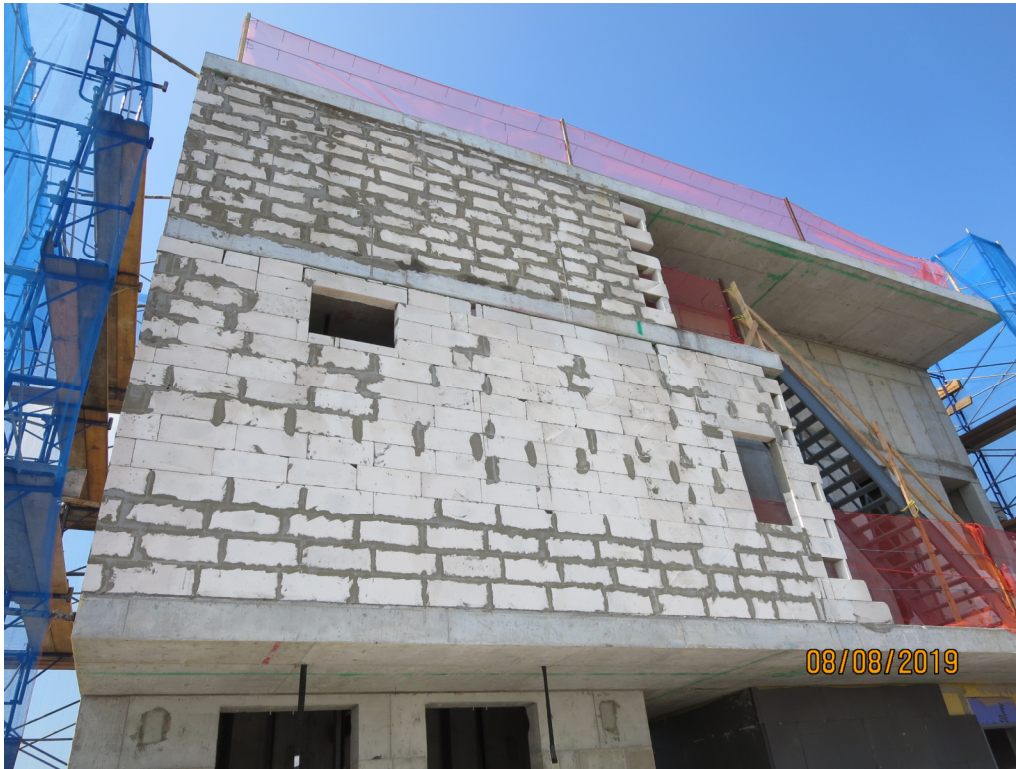
TYPICAL WALL SECTION WITH EIFS | 2
1 1/2" = 1'-0" | A-420.00

Not So Typical Construction Types – AAC Block

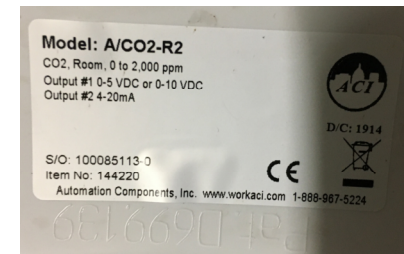
CHK-3-2 **PENDING VERIFICATION** Actions Watch

TAB Report dated 2019-09-27 does not include measurements with DCV dampers at their minimum/low positions. Measurements should be provided at both min and max positions. (See also EP Engineering comment #2 on their review)

Additionally, the actual programmed damper positions (i.e. % open) should be noted for each damper at min and max positions.

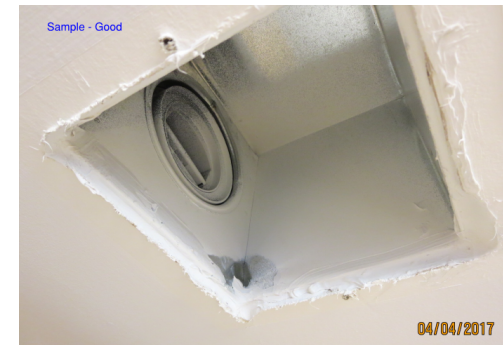
CAR Damper: CAR dampers must be used at all registers to achieve proper balancing. Make sure to use CAR dampers like the one pictured here, with a set screw to adjust the flap.

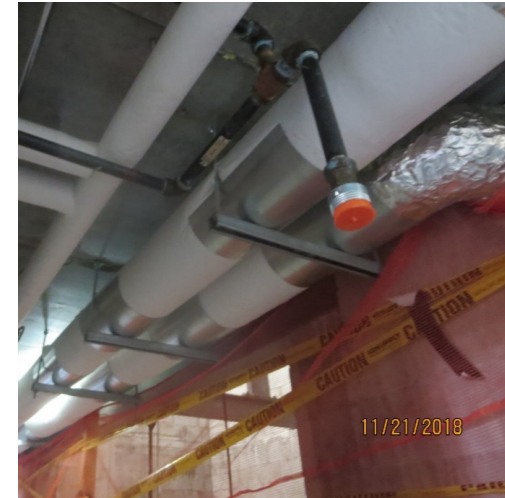
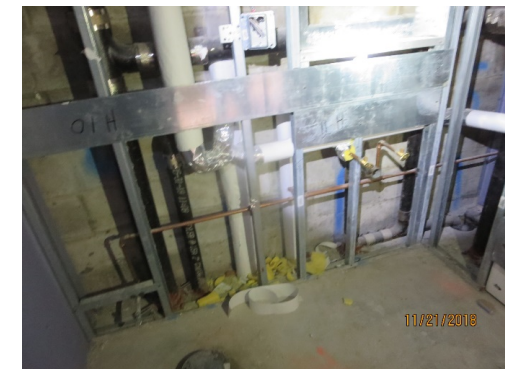
- Follow P-001.00 for DHW, including crotons
- Insulation to be continuous at all hanger locations (kindorf & clevis)
- Runout piping

PLUMBING PIPING INSULATION				
MATERIAL	MANUFACTURER	SERVICE	INSULATION THICKNESS	COMMENTS
FLEXIBLE ELASTOMERIC	AEROFLOX USA INC.; AEROCEL ARMACELL LLC; AF ARMAFLEX RBX CORPORATION; INSUL-SHEET 1800; INSUL-TUBE 180	DOMESTIC HOT & RE-CIRCULATED HOTWATER	1" FOR PIPES < 1.5" 1½" FOR PIPES ≥ 1.5"	1) FLAME SPREAD RATING INDEX SHALL BE 25 OR LESS. 2) SMOKE DEVELOPED INDEX SHALL BE 50 OR LESS. 3) PIPE INSULATION SHALL NOT BE INTERRUPTED BY PIPE SUPPORTS OR PIPE SERVICE.
		DOMESTIC COLD WATER (POTABLE)	1"	
		STORMWATER & OVERFLOW	1"	
		ROOF DRAIN AND OVERFLOW DRAIN BODIES	1"	
		EXPOSED SANITARY DRAINS	1"	
MINERAL-FIBER	FIBREX INSULATIONS INC.; COREPLUS 1200. JOHNS MANVILLE; MICRO-LOK. KNAUF INSULATION; 1000 PIPE INSULATION. OWENS CORNING; FIBERGLAS PIPE INSULATION	DOMESTIC HOT & RE-CIRCULATED HOTWATER	1" FOR PIPES < 1.5" 1½" FOR PIPES ≥ 1.5"	1) FLAME SPREAD RATING INDEX SHALL BE 25 OR LESS. 2) SMOKE DEVELOPED INDEX SHALL BE 50 OR LESS. 3) PIPE INSULATION SHALL NOT BE INTERRUPTED BY PIPE SUPPORTS OR PIPE SERVICE.

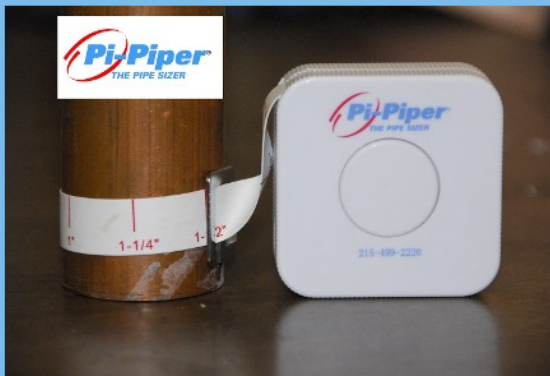
The Pipe Sizer Provides a Viable Solution To Measuring Pipe Sizes

The Pipe Sizer Provides a Quick Solution for Measuring Pipe Size (diameters)

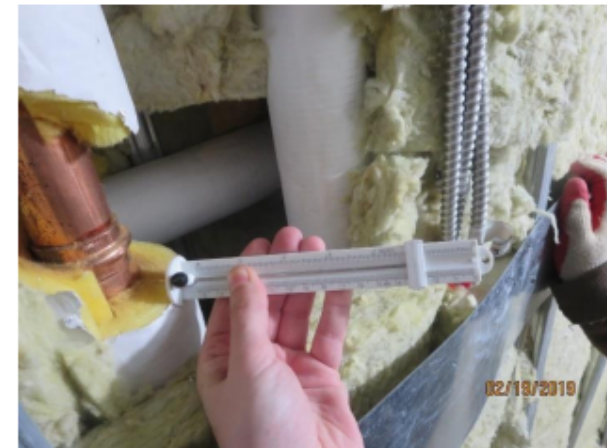
1.5" diameter hot water piping observed with only 1.0" thick insulation, 9th floor

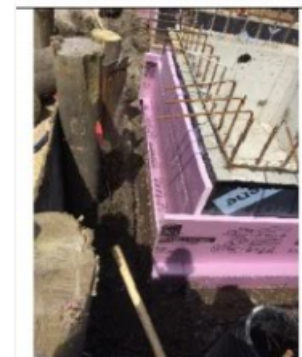
Insulation at grease trap area prior to backfill

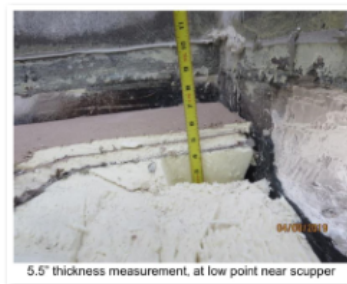
Roof Bulkhead - 03.JPG

5.5" thickness measurement, at low point near scupper

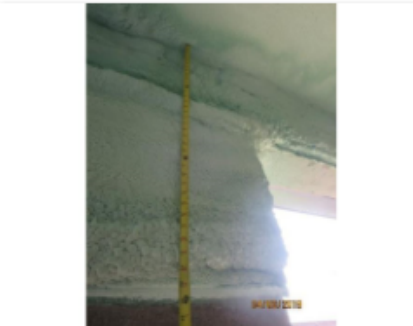
Garage Ceiling 04.JPG

Thickness measurement, insulation extending down vertical 3'

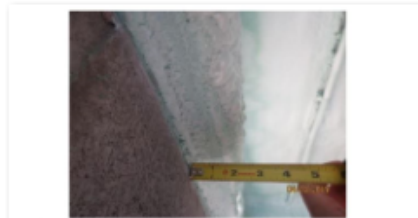
Garage Ceiling 05.JPG

Thickness measurement, 2' spray foam at vertical

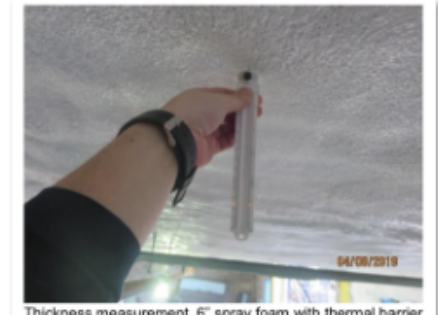
Garage Ceiling 06.JPG

Thickness measurement, 6" spray foam with thermal barrier coating at horizontal

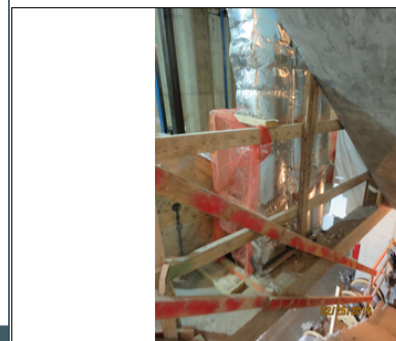
Notes: Duct insulation (indoors)

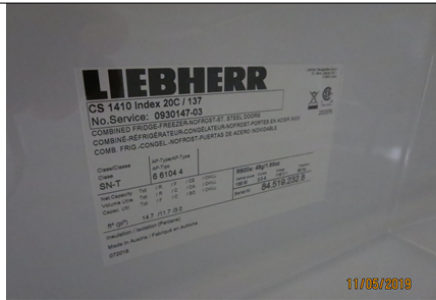
Notes: Nameplate – Liebherr CS 1410

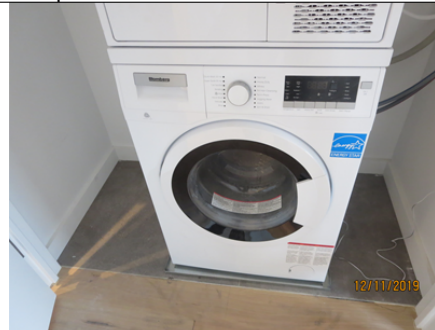
Notes: Overview (washer)

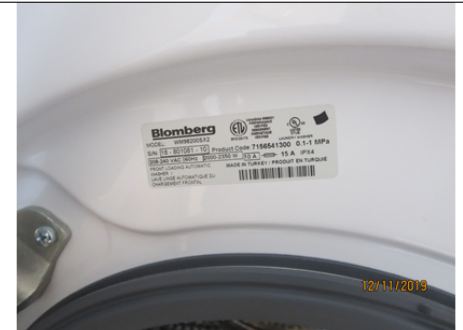
Notes: Nameplate – Blomberg WM98200SX2

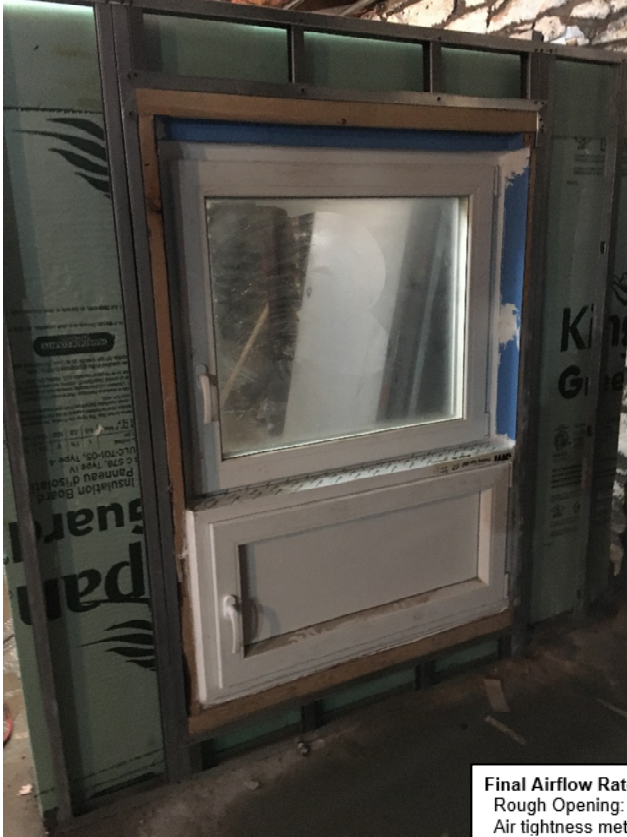
Pre-Construction Window mockup test

Final Airflow Rates:		
Rough Opening:	45" x 58"	Tested Pressurization: 2.0 CFM50
Air tightness metric:	0.08 CFM/sf	Tested Depressurization: 1.7 CFM50
Airflow Target:	1.45 CFM50	Tested Average: 1.85 CFM50

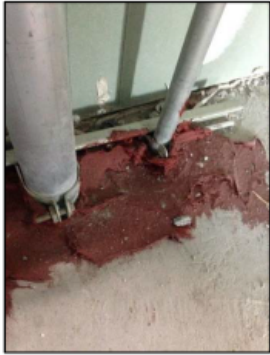
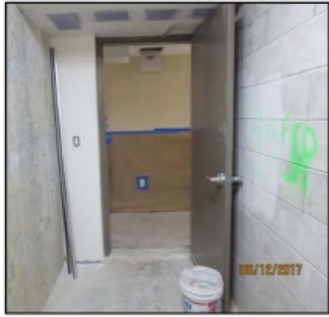
Item #	Inspection	Detail Date
U - 6	Gas Meter Room	Bulletin 1 - 01/24/2018
Description		
<p>Louver vent installed with continuous sealant around perimeter. Door to the room must fully be gasketed and weather stripped. Gas room penetrations must be air sealed.</p>		
Images		
<div style="display: flex; justify-content: space-between;"> <div style="width: 30%;">

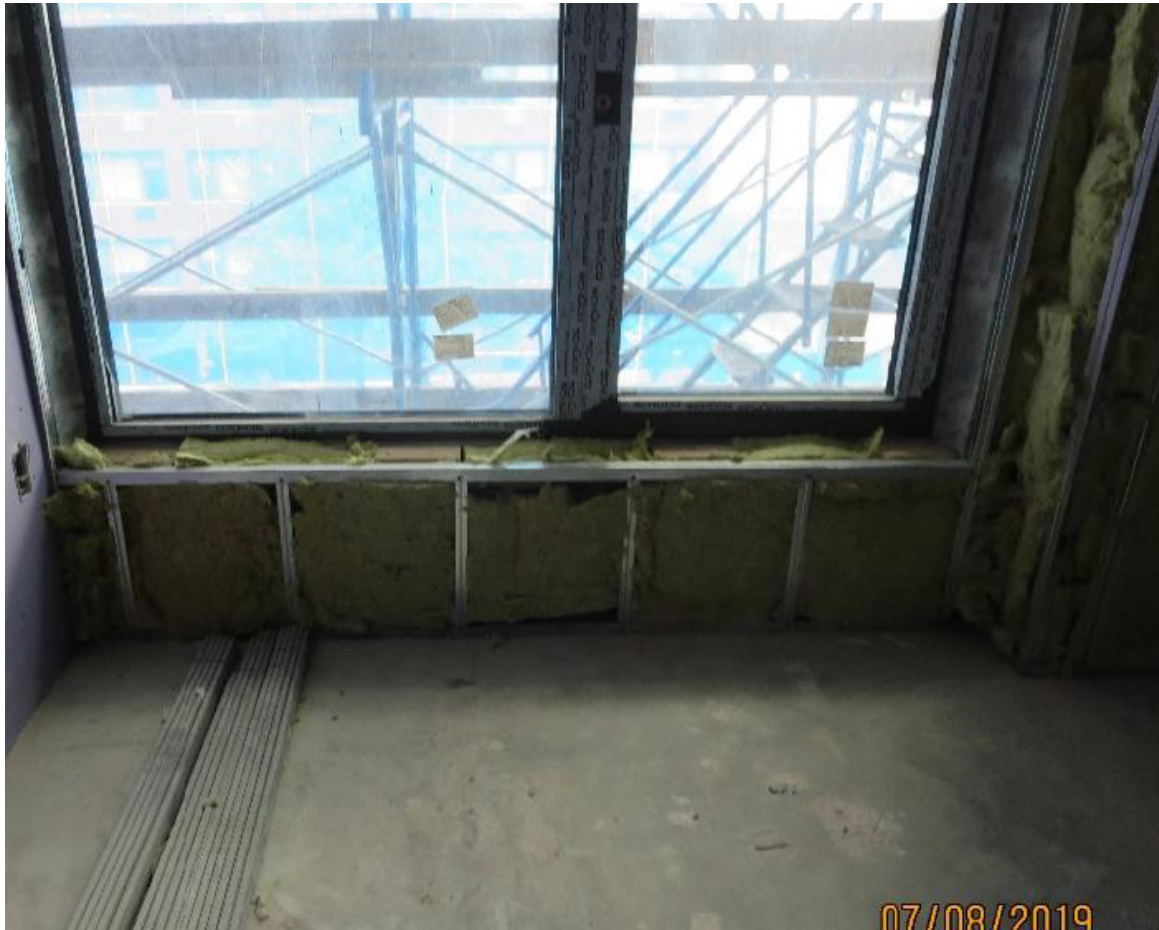
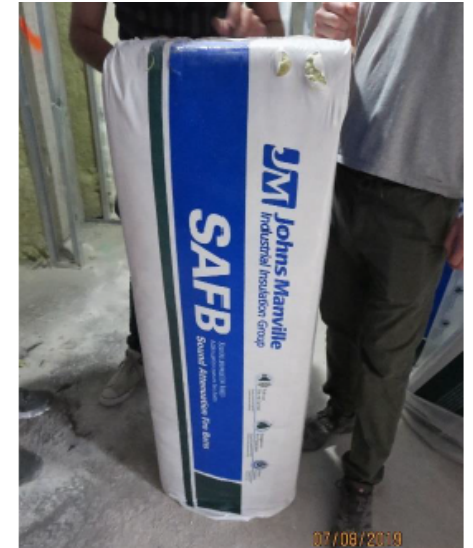
Product observed on site does not match the submittal

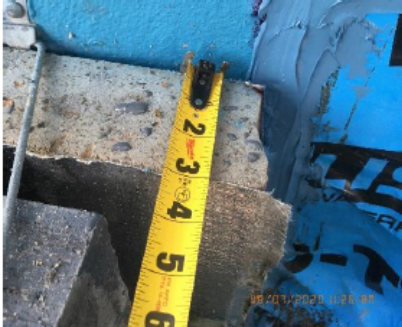
<p>Photo from Monadnock showing installer filling gaps with spray foam.</p>

<p>Thickness measurement indicating 3".</p>

Item #	Description and Action Required	Images
1	<p>Insulation placement and R values</p> <p>Drawing References: A-313, A-312 Submittal: 072100-02.0</p> <p>Description: SWA observed the installation of 3" Kingspan insulation on the above-grade walls in progress at the north tower, west and interior court north elevations floor 4-5.</p> <p>SWA requested progress photos to verify the gaps in insulation boards were being filled before being covered up with brick. Monadnock provided photos 8/10/2020, and these look good.</p> <p>Continue installing boards joined tightly without gaps and filling any gaps that do exist with spray foam.</p> <p>Required Actions: - None</p>	  <p>Overview of the application on the west elevation.</p>

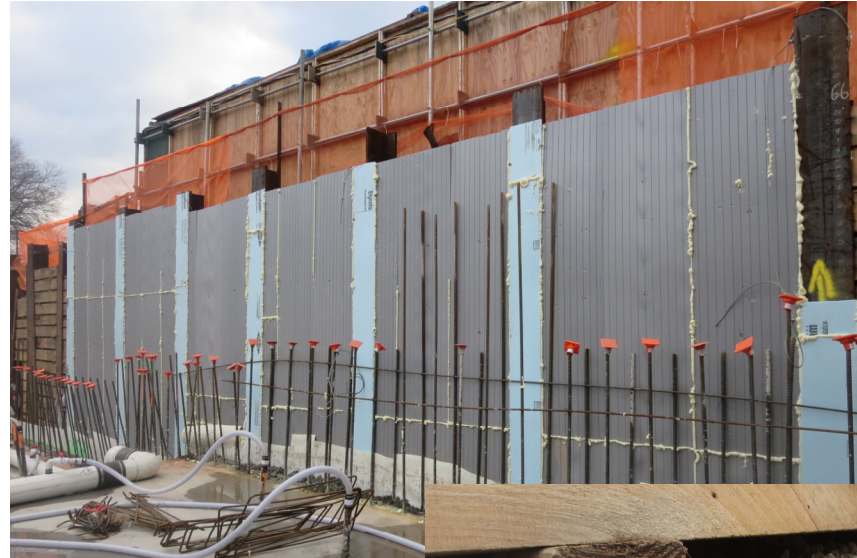
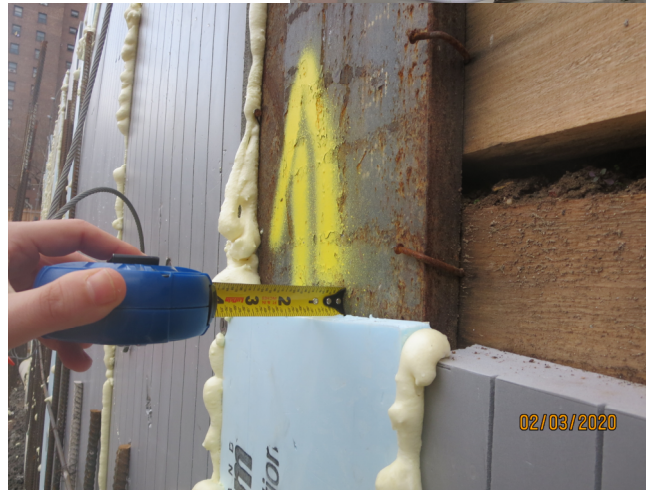
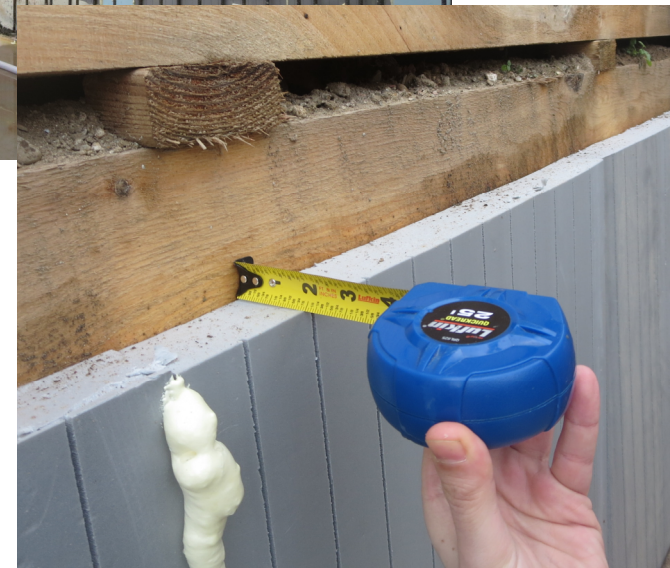
Example: blind side conditions

- excavation support lag wall to be used as foundation formwork

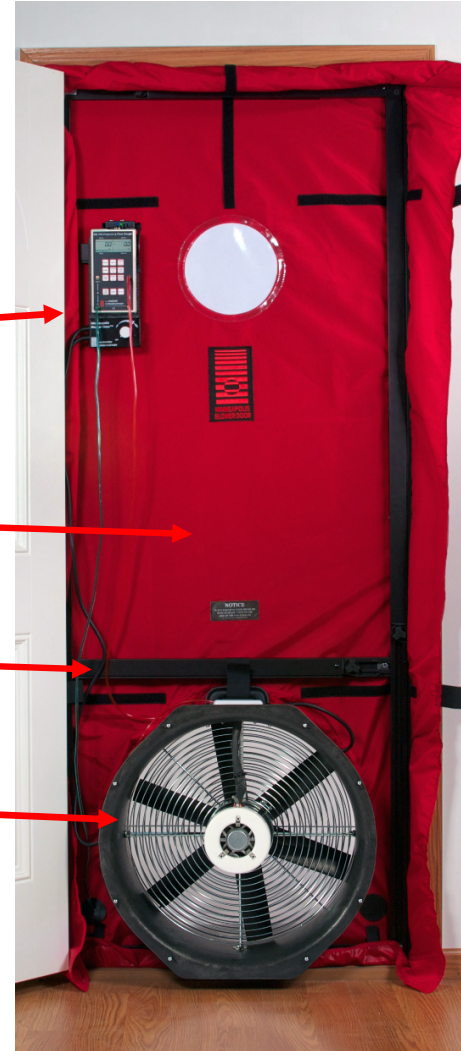
Blower Door Testing

- Basic Components
 - Gauge (manometer)
 - Shroud
 - Frame
 - Fan

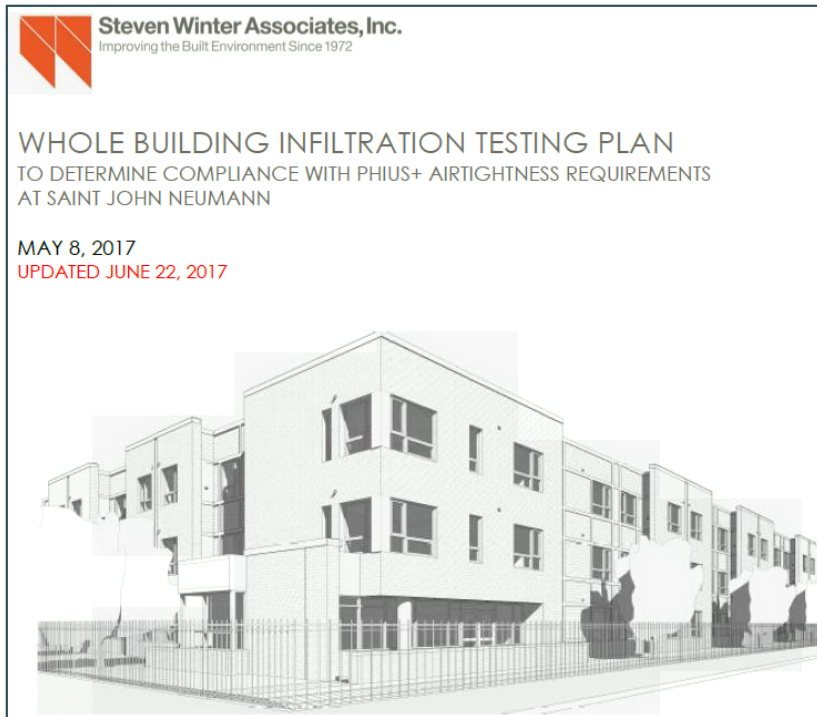
Intentional Opening	Test Setting	Notes
Windows, doors, skylights in the building enclosure	Closed and latched	
Doors and operable windows inside the test enclosure	Open	Use stairways to connect all zones of the building
Fire dampers	Remain as found	
Dryer doors	Closed and latched	
Gas meter room	Door to gas meter room closed and weather stripped	
Waste handling system	Trash chute termination at roof taped off. Door to trash rooms closed.	
ERVs (apartments)	Fan off, any dampers closed. Ducts to the outside sealed inside the ERV cabinet in each apartment.	Ventilation is continuous, so can remain taped off
Motorized dampers: ERV-4 (cellar)	Fan off, dampers closed. Taped off from the exterior	Ventilation is continuous, so dampers closed and sealed off
Motorized dampers: ERV-5 (1 st floor)	Fan off, dampers closed. Taped off from the exterior	Ventilation is continuous, so dampers closed and sealed off
Motorized dampers: ERV-2A (1 st floor)	Fan off, dampers closed. Taped off from the exterior	Ventilation is continuous, so dampers closed and sealed off

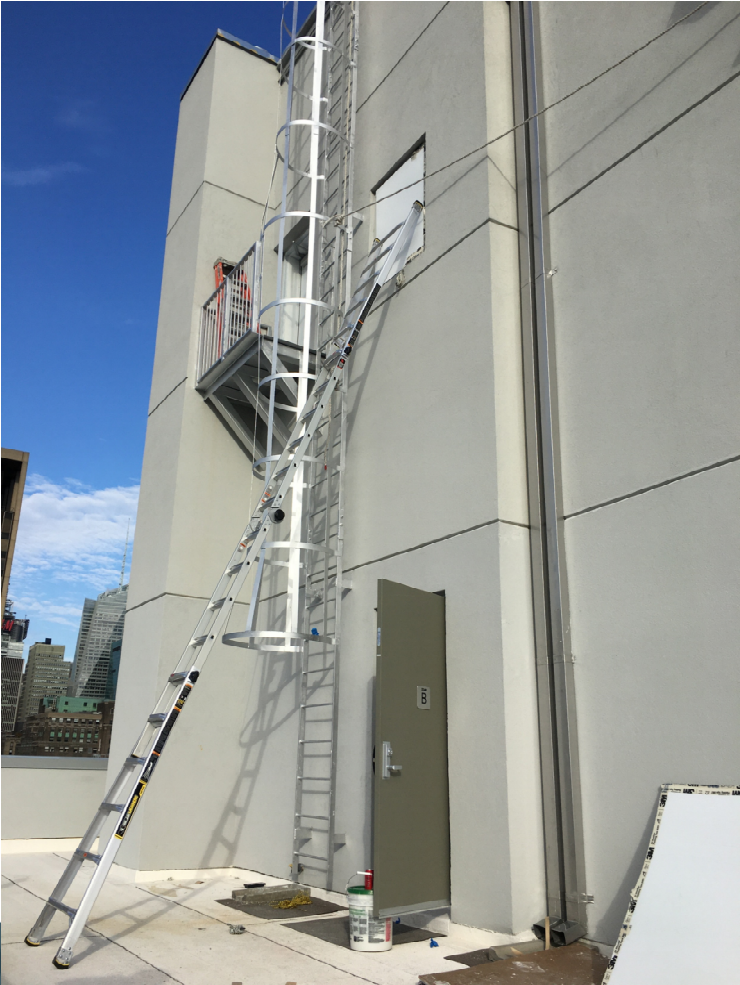
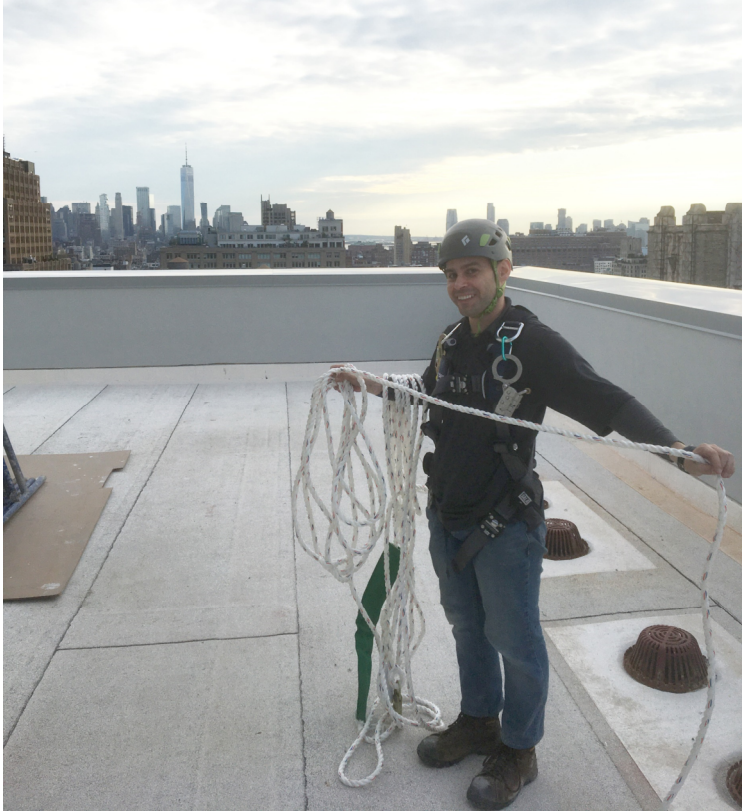
Whole Building Prep Work

- Enough fans, cruise manometers, frames, shrouds, tubing, CAT5 cabling, people?
- Is building access limited to avoid people opening and closing doors, windows, etc.?
- Thorough walkthrough the day prior to test date to confirm prep has taken place?
- GC and appropriate subs on site to help with building prep and issues that come up on the test day?
- Saturday work permits active?
- COVID concerns?

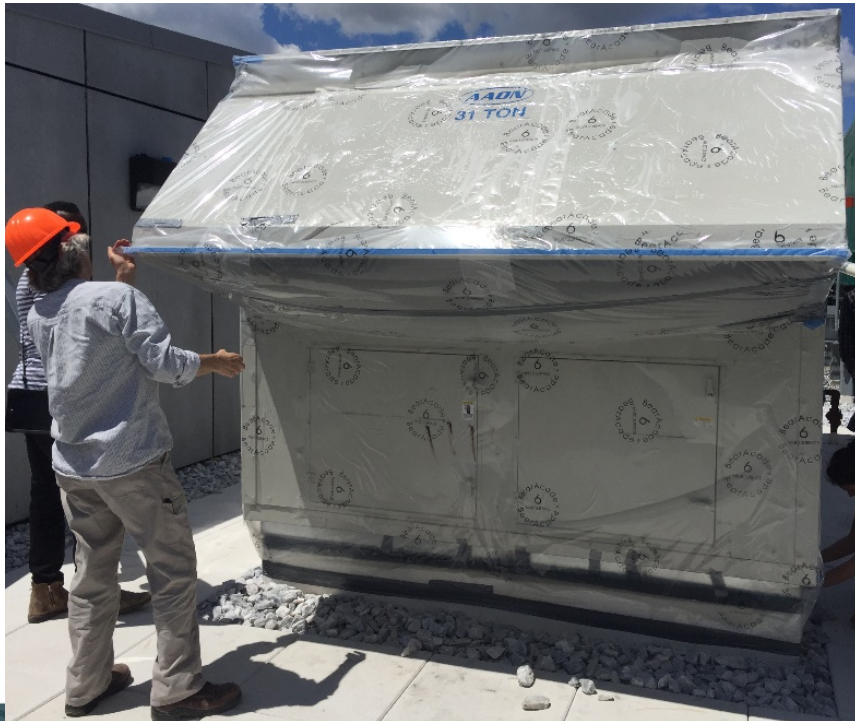
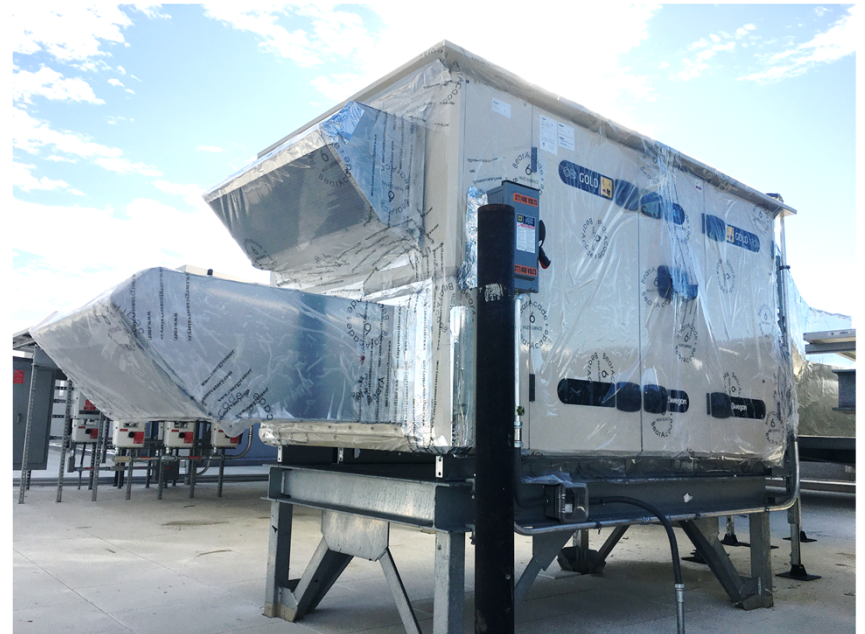
Central ERVs and Blower Door

- Need to seal off ERVs for the test
- Wrap rooftop ERVs and/or seal exterior intake and exhaust louver ports

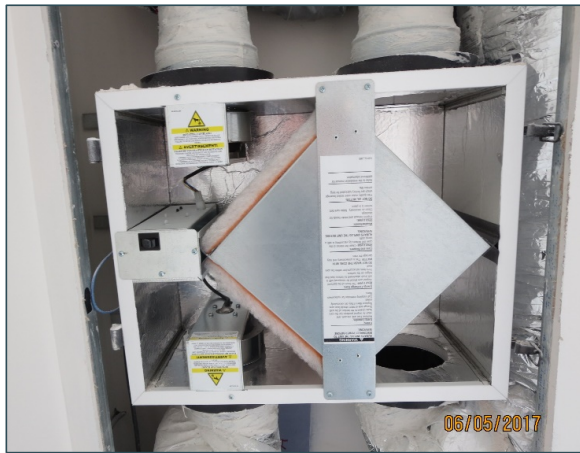
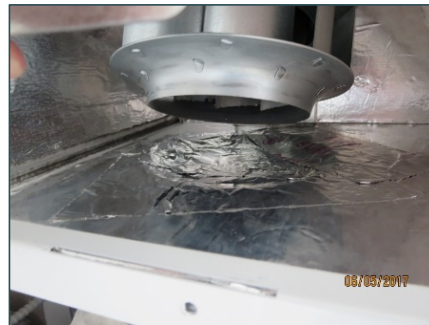
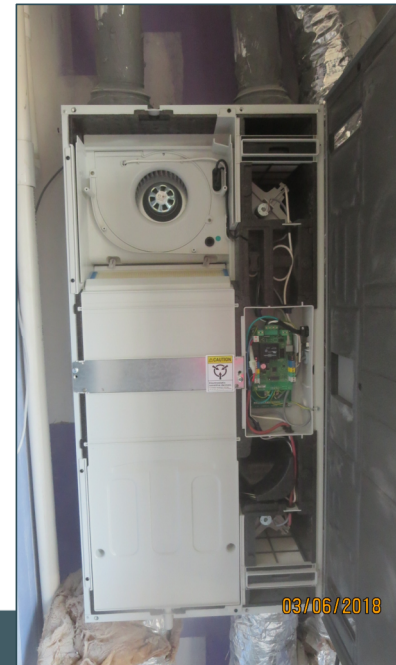
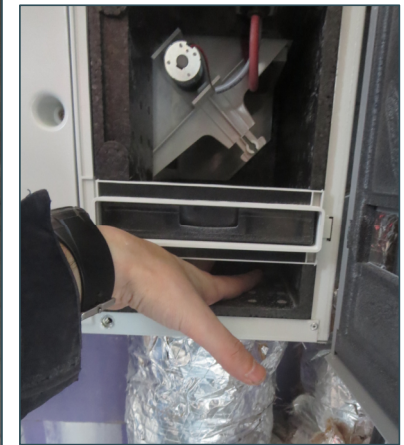
Individual ERVs and Blower Door

- Typically can't reach all vents to seal from outside
- Tape off both outdoor connection ports inside every ERV
- Some ERV's can't be sealed inside the cabinets
