## **Magnesium-oxide boards cause moisture damage inside facades in new Danish buildings**

**Hansen, Kurt Kielsgaard; Bunch-Nielsen, Tommy; Grelk, Bent; Rode, Carsten**

International RILEM Conference on Materials, Systems and Structures in Civil Engineering 2016

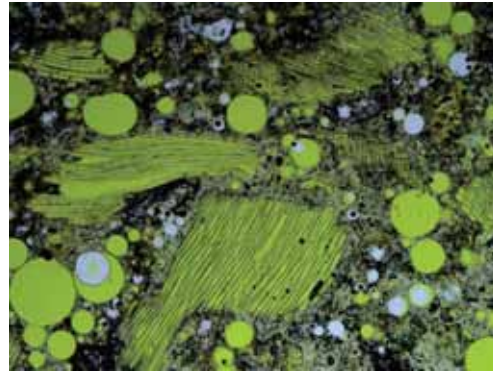
Figure 8: Micro analysis of a thin section of a specimen at 50 times magnification.

The hydrated product is hard and strong but the product decomposes over time by contact with water or air at high relative humidity (RH). The durability problems with this material are reason that the material has so to speak been forgotten in the following years. However, within the last 10 years a relatively high number of so-called MgO products (MgO-boards) have been put on the market within the building industry. MgO-boards have a composition, which is very similar to hydrated Sorel cement but has both organic additions, such as sawdust (wood flour), and inorganic filler additions such as sand, lime or volcanic ash – even though it may not be stated in the data sheets for MgO-boards. Figure 7 shows a cut of an MgO-board analysed in a stereo microscope at 10 times magnification. The analysis shows that the investigated MgO-board contains a high amount of organic material such as wood fibres or sawdust, and a high number of fine spherical air pores. Figure 8 is a micro analysis of a thin section of a specimen at 50 times magnification that verified both the considerable

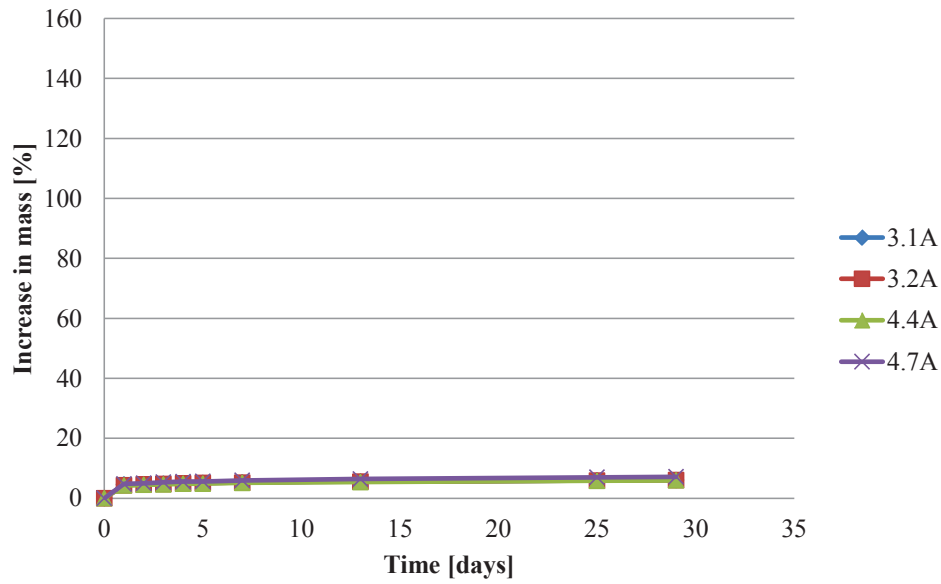
Figure 11: Course of the moisture retention at 35% RH.

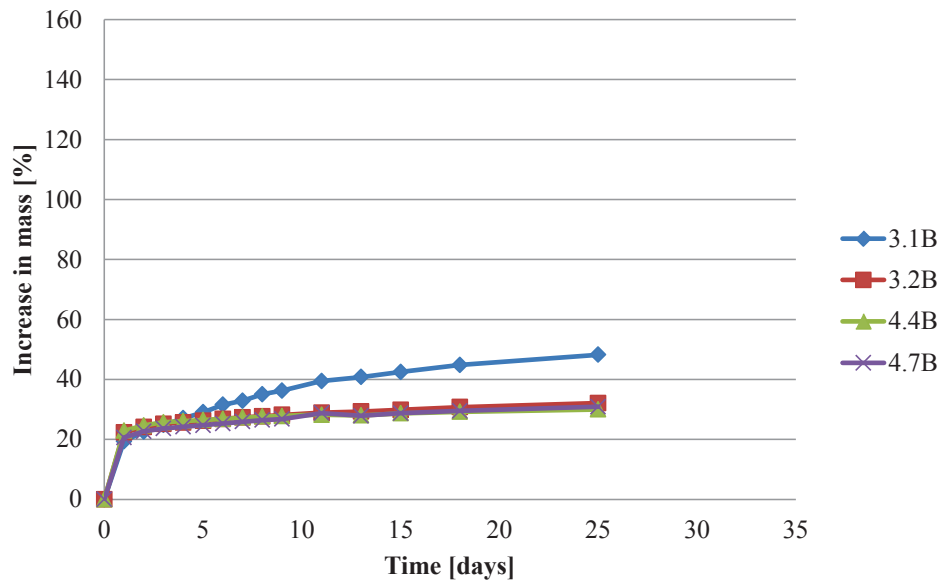
Figure 12: Course of the moisture retention at 80% RH.
